Accessory Product Information

Europe - November 2018

RIM HORN WEAR: HOW TO REMOVE SHARP EDGES?

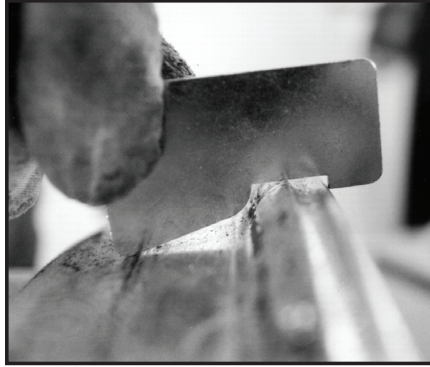
Moderate and even severe rim horn wear is a normal occurrence on both steel and aluminium wheels and on all types of wheels. In many instances, it is non-existent even after several years of service. However, the inspection for wear and sharp edges should be part of ongoing preventative maintenance.

Irregular wear on the surface of the rim flange is caused by bulging and flexing of the tyre side wall which in turn creates sharp edges on the wheel and therefore might damage the tyre.

Simply remove the sharp edges by means of a metal file, sanding machine or grinding machine.

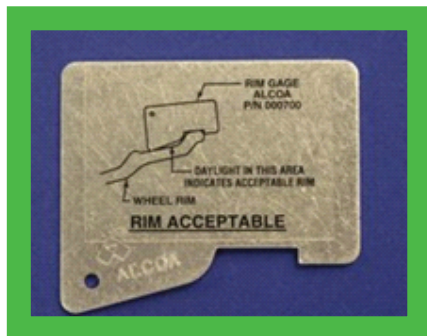
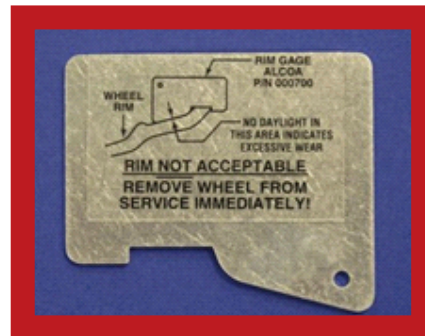
4. Check the rim horn height again with the rim horn wear gauge to make sure there is adequate height remaining to safely support the tyre. If the entire wheel flange is within the limits of the gauge, the wheel may be returned to service. See graphic 13-25 and 13-26.

Permanently remove any wheel from service that has inadequate rim flange height - **if you are unable to see any daylight under the gauge area** - (see graphic 13-27) as this can lead to an explosive separation of tyres and wheels!
